SCREENING SITE INSPECTION REPORT  
FOR  
CARSTAB CORP  
READING, OHIO  
U.S. EPA ID: OHDO00724138  
SS ID: NONE  
TDD: F05-9008-013  
PAN: FOH0022SA

AUGUST 19, 1991

**ecology and environment, inc.**

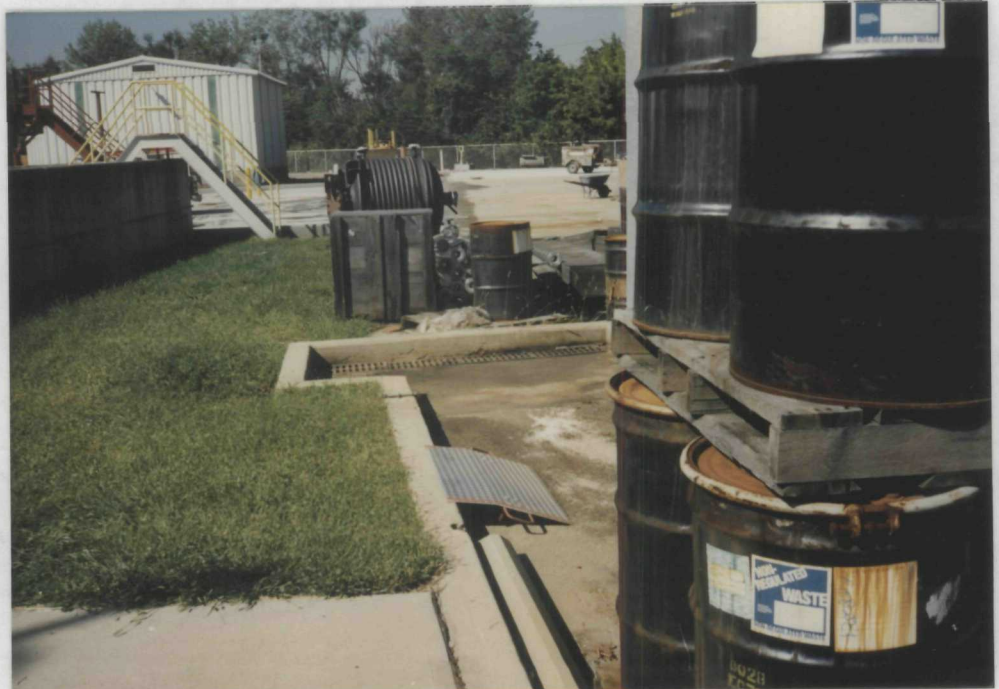
DESCRIPTION: A photo of the Hazardous Waste Storage  
area drainage system.DATE: 10/1/90TIME: 11:55DIRECTION OF  
PHOTOGRAPH:WestWEATHER  
CONDITIONS:ClearTemp  $\approx$  70 $^{\circ}$ F

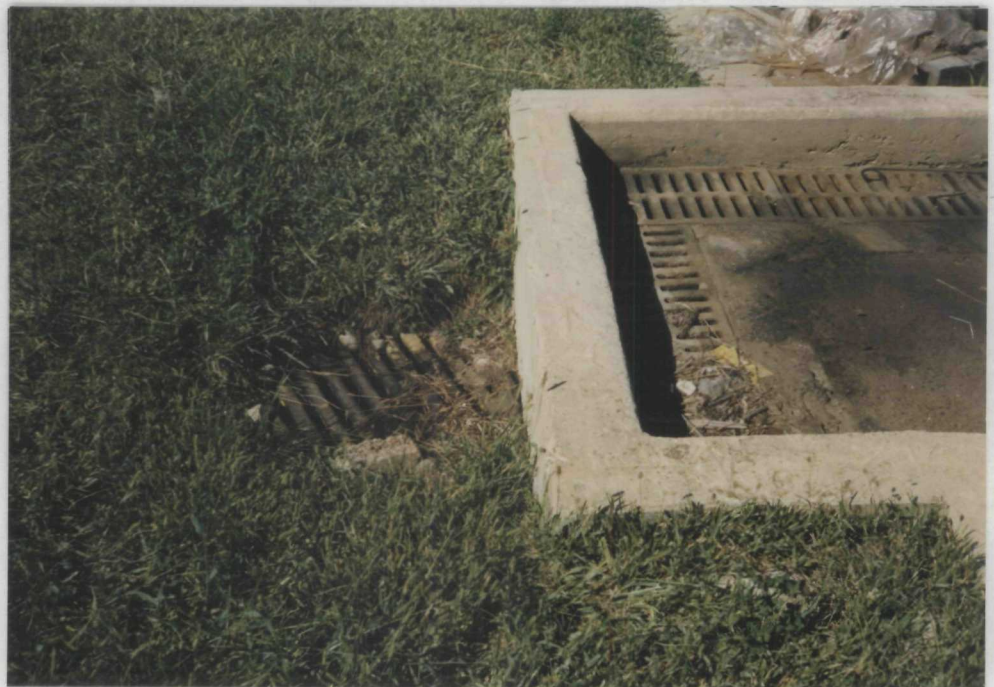
DESCRIPTION: A close-up photo of the Hazard  
Waste Storage area drain.

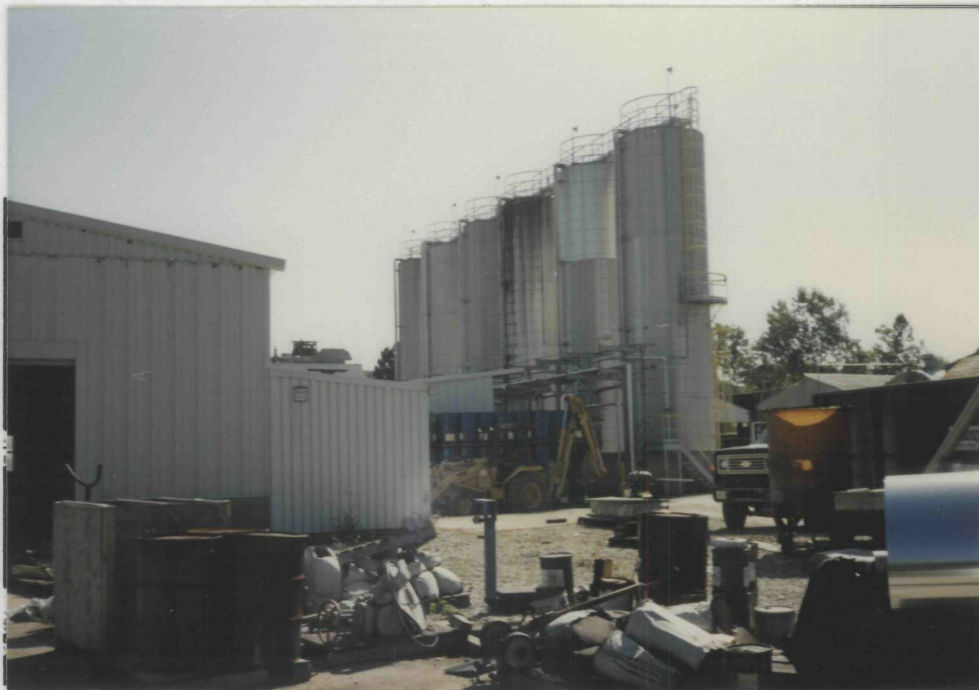
DESCRIPTION: Storage Tanks for feedstocks.DATE: 10/1/90TIME: 11:37DIRECTION OF  
PHOTOGRAPH:WestWEATHER  
CONDITIONS:Temp  $\approx$  70°FClear Sky

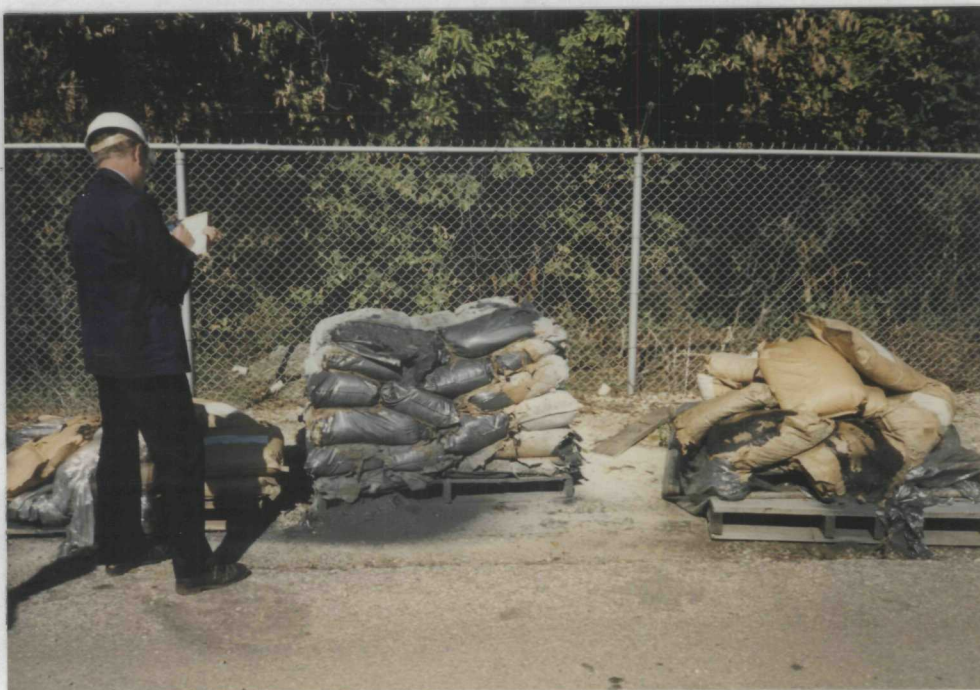
DESCRIPTION: Carbo-Alkor powder being stored on  
pallets. This storage area is located on the Northwestern  
of the site.

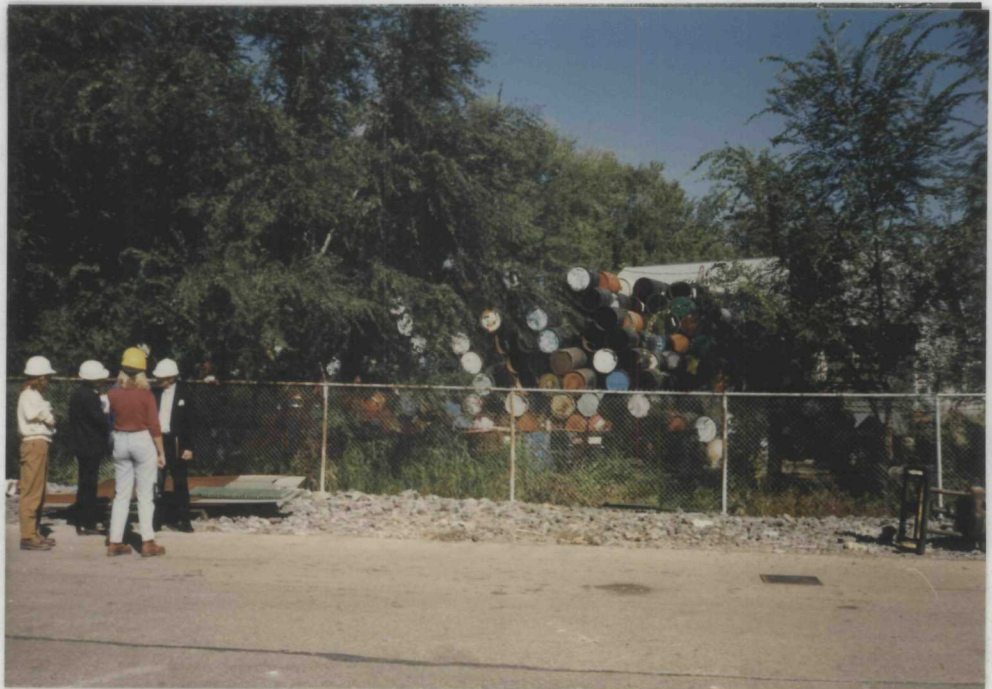
DESCRIPTION: A photo of drums stored on the property  
to the north of the Carstab site.DATE: 10/1/90TIME: 11:57DIRECTION OF  
PHOTOGRAPH:North westWEATHER  
CONDITIONS:Clear,Temp  $\approx$  70°F

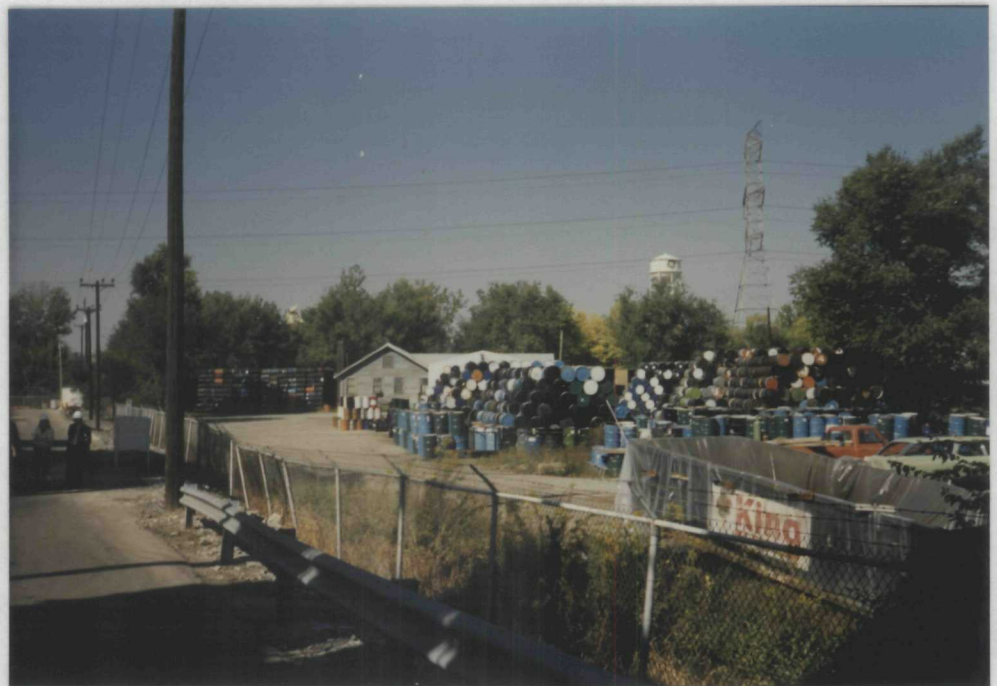
DESCRIPTION: Another photo of the property north of Carstab  
This photo was taken east of the photo above.
